# CHICKEN HOUSE/WASH HOUSE

**Carl Sandburg Home NHS**  
Flat Rock, North Carolina

## HISTORIC STRUCTURE REPORT

**September 2007**

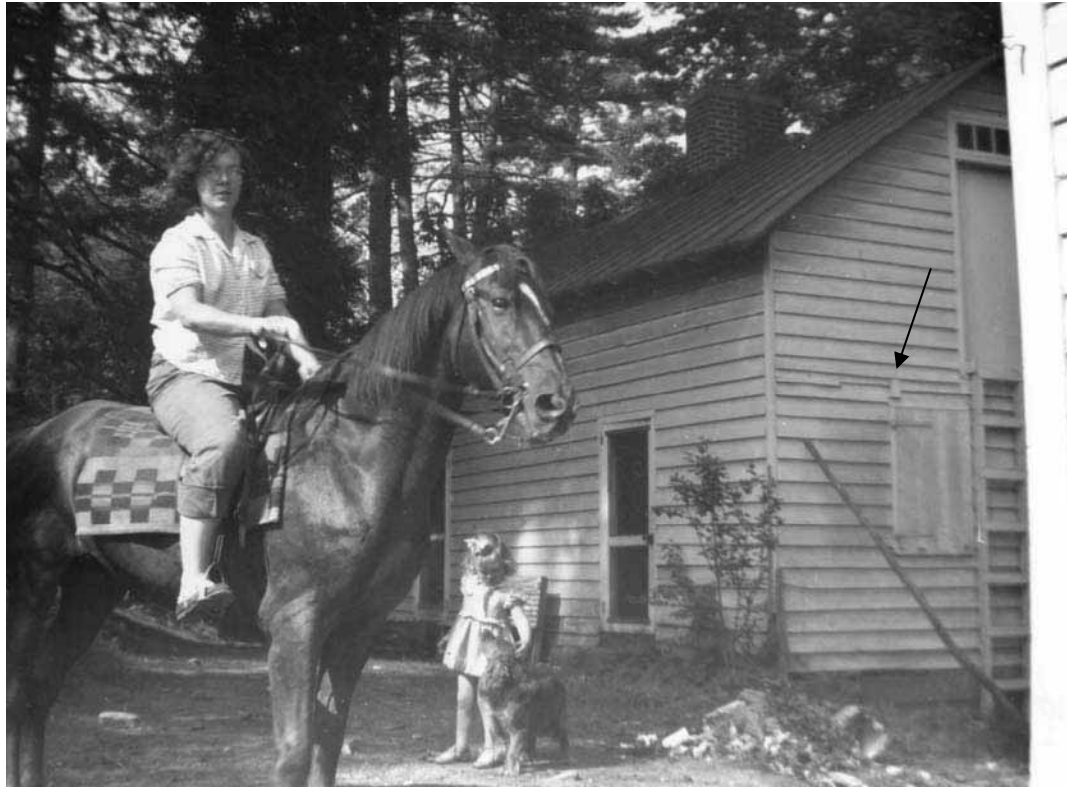
**Figure B-2** Helga Sandburg on horse, with daughter Paula outside Chicken House, c. 1946. Note framing protruding from siding at arrow and lack of goat entrances on north elevation, and ladder aligned with eastern window. (CARL3000/08/25P)

Photographic documentation from the early Sandburg occupancy shows that there once were two framing members protruding from the weatherboard siding on the north elevation, on either side of the door to the second level, approximately at floor level. One of these is still existing, and measures 4 ½" by 3 ½". It is plausible that these are remnants of early landing framing that survives behind the siding. Selective removal of building elements to expose framing and archaeology would likely identify important design characteristics of this feature.

The same photograph shows the ladder on the north elevation providing access to the upper level. It was not centered beneath the upper door, but rather adjacent to the eastern (left) window. The ladder remains, but is

now aligned with the western (right) window, suggesting that it was moved mistakenly during the 1970s renovations.

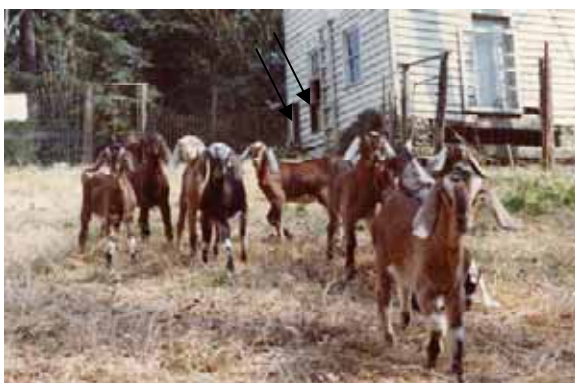
**Figure B-5** Nubian kids in Chicken House yard.  
Note two small openings added on north elevation.  
(CARL3000/44/103P)

Low openings were made on the north elevation for the goats, one near the northeast corner and another under the adjacent window. An exterior wood ramp with applied battens for traction was constructed for kids to enter through the easternmost window.

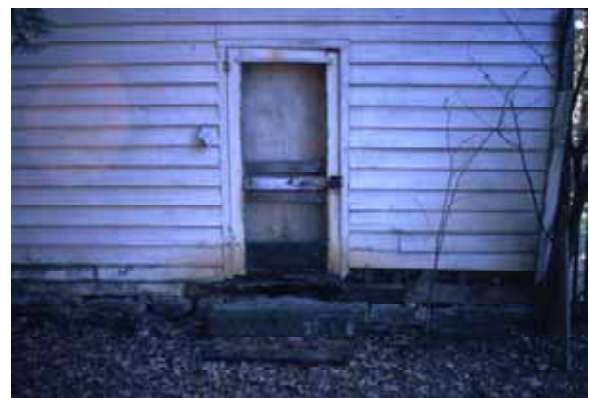
**Figure B-8** North door on east elevation, Dec. 1973  
(CARL4024/6/02)

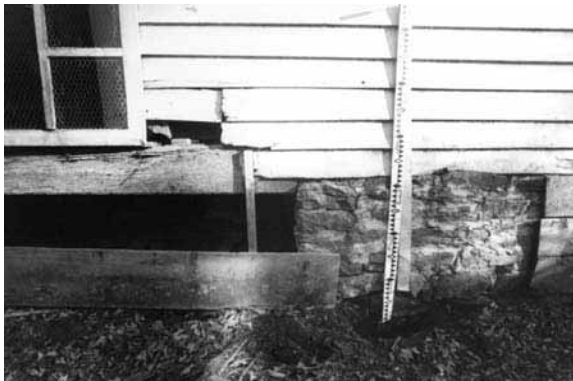
Further evidence from period photographs shows deteriorated siding near the northeast corner of the building on the north and east elevations, missing siding and a sagging sill along the west elevation, and sections of windows covering the door openings on the south elevation. Shutters were missing on the north elevation, in addition to some window muntins.

**Figure B-9** Partial west elevation, Dec. 1969.  
(CARL4012/3)

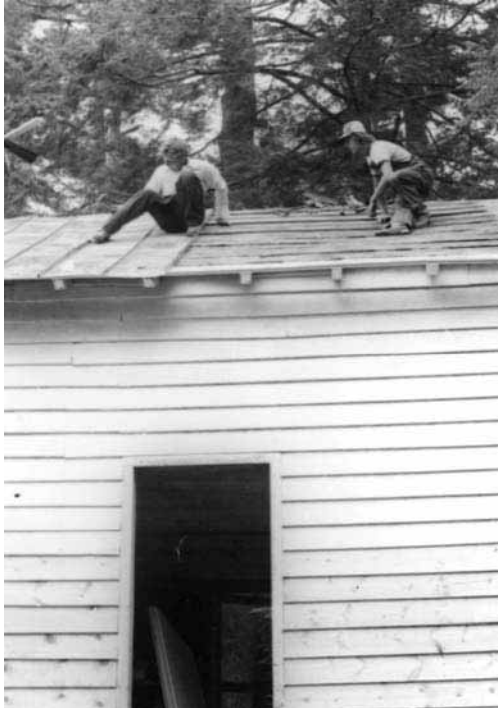
**Figure B-15** Roof repairs in progress, May 1978 (CARL4008/05/46P)

A purchase order for roof replacement dated September 23, 1977, indicates that McCall Sheet Metal & Roofing, Inc., was awarded a contract for \$965 for installation of a new standing-seam tin-coated metal roof and flashing of the chimney. An amendment to

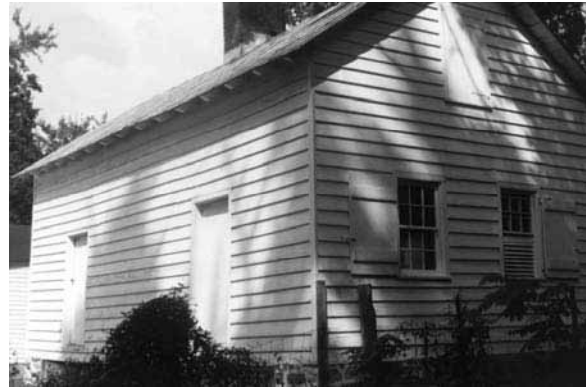
**Figure B-18** Southwest oblique of Chicken House, presumably showing completed repairs, 1985 (CARL4004/21-02P)

An undated, handwritten report entitled "Plan of Action: Cyclic Maintenance, Painting Exterior of Chicken House" is assumed to have been written to address the conditions documented in August 1985. The report indicates that the exterior of the building, including siding, cornice, windows, and shutters, was to be washed using Jomax mildew remover, and followed with primer and paint with mildew inhibitor added. It indicates that shutters were to be repaired, and one replaced. Under the category of "Foundation," it states the following: "repair underpinning taking special consideration to the original, replace only what is necessary and restore to original appearance; vent foundation by leaving cracks between underpin boards and screen behind boards to keep out pests." It is assumed that this work was carried out, though photo-documentation of the repairs is sparse.

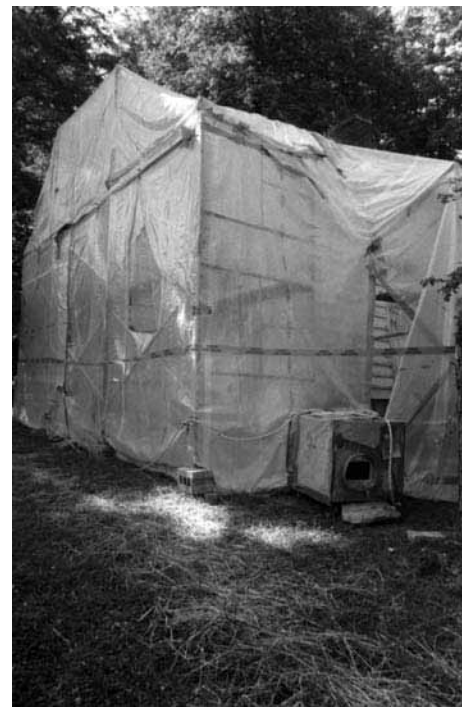
**Figure B-19** Northwest oblique, showing tent for lead abatement, 2001 (CARL4018/2-116P)

The most recent work to the Chicken House/Wash House occurred in 2001, when a lead abatement project resulted in the entire building's being tented, completely stripped of exterior paint, and repainted. Similar abatement took place at the Swedish House. The work was completed by Blue Ridge Environmental Specialists of Horse Shoe, North Carolina.

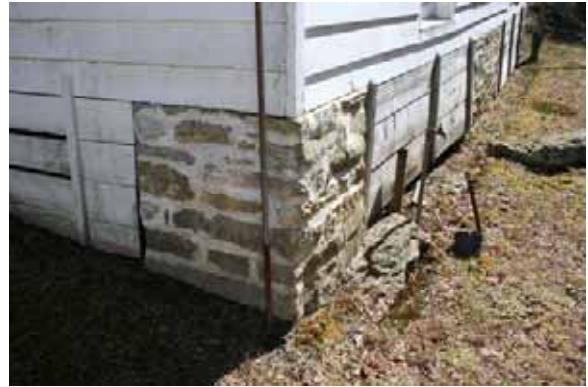
**Figure C-27** Northwest corner of building showing wooden panels at foundation level

Two large openings in the west foundation wall and one on the north lead to the crawl space below the building. Each opening is covered by a modern wood panel built of three horizontal boards connected with three vertical battens. The panels are nailed in place to the frame walls through the top of the battens. The horizontal boards are spaced slightly to allow ventilation to the crawl space. These wood panels are unpainted on the west elevation and painted on the north elevation. The panels are 1970s replacements for earlier, deteriorated board panels visible in Sandburg-era photographs.

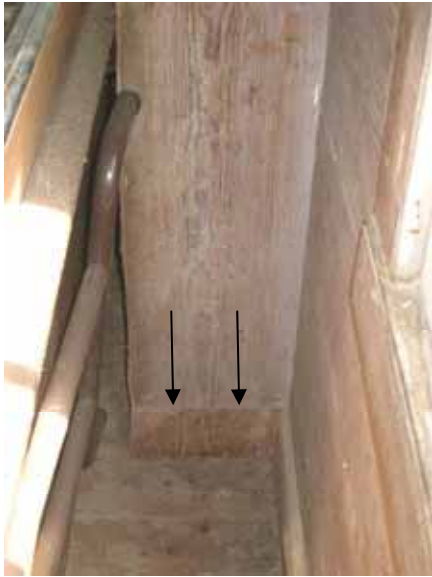
**Figure C-30** Section of early board wall at east side of Room 101A, with baseboard ghost mark

- **Baseboards:** Early if not original baseboard is present along all existing sections of wall. The baseboard is <sup>3</sup>/<sub>4</sub>" by 5" and has a <sup>3</sup>/<sub>8</sub>" bead with <sup>1</sup>/<sub>8</sub>" quirk. A corresponding ghost mark is visible on the remaining fragment of east vertical board wall.

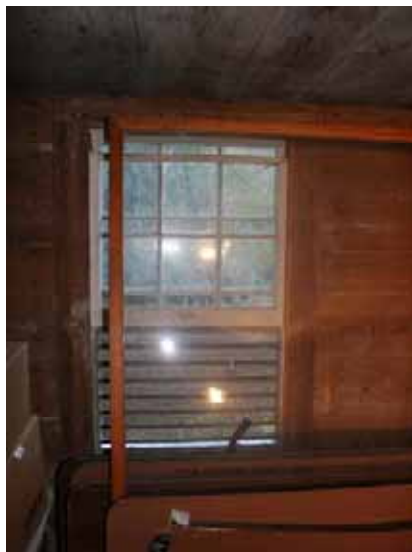
*Figure C-33 Interior of louvered window*

- *Windows:* One wood six-over-six double-hung window is along the south wall. Its interior casing is a 4" board with a 1/2" applied stop with 3/8" bead. The window is in a raised position with a wood louver installed in the lower portion of the opening.

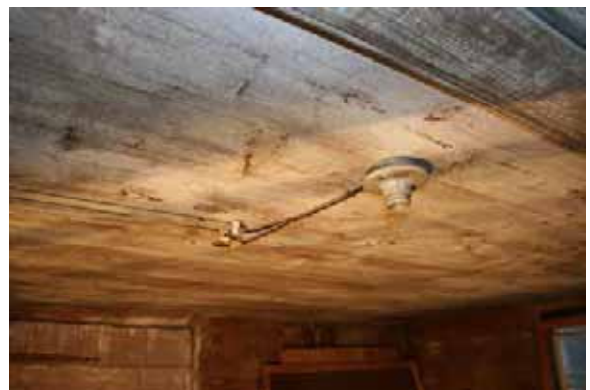
*Figure C-34 Ceramic light socket in Room 101B*

- *Electrical Systems:* A ceramic light socket is mounted on the ceiling near the west side of the room, serving to illuminate both this room and the adjacent Room 101A. Two-wire knob and tubing extends east from this socket and then turns north to the remainder of the building. Electrical service to the building is not operational.

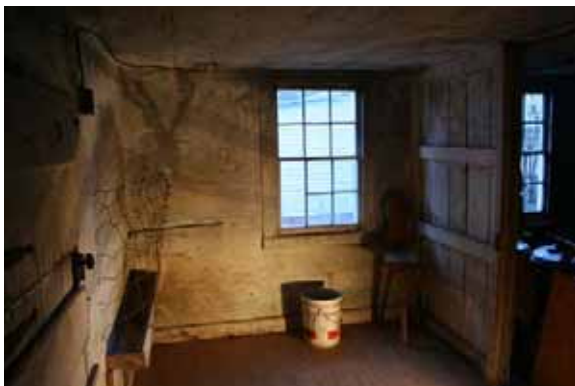
*Figure C-35 Room 102A looking north*

- **Flooring:** The flooring is 1" thick tongue-and-groove pine in widths from 5" to 5 1/4", varying in 1/8" increments. The flooring appears newer than that of the south half of the building, and probably dates to the 1920s when the building was made a wash house. Records indicate that some work was done to this flooring in 1982; it is not known whether repairs were made or sections replaced.

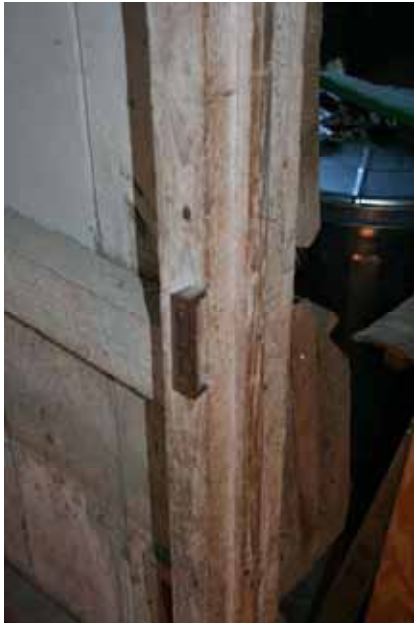
**Figure C-37** North jamb of door opening in east wall

A door opening in the center of the room on its east wall currently contains a rough wood gate opening into the adjacent Room 102B. This opening has two hinge leaves in place on the south jamb indicating that a door was once in place opening into Room 102A. It also retains a keeper on the north jamb for a rim lock. The opening is made for a 2'-10" by 6'-8" door.

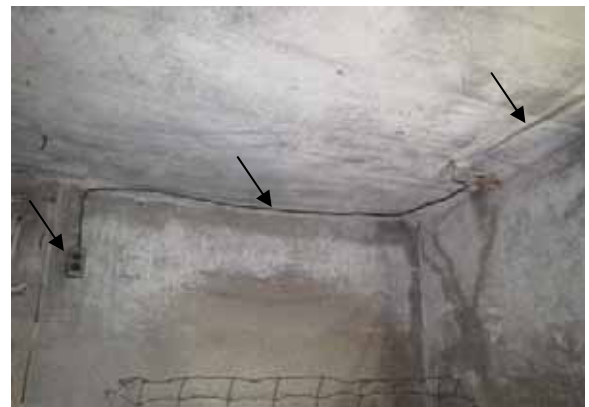
**Figure C-38** Outlet and Romex along west wall, two-wire knob and tubing along north wall

- *Electrical Systems:* An outlet mounted high on the west wall, just north of the door, is supplied by Romex wiring which extends along the ceiling to the electrical service point at the north wall.

Two-wire knob and tubing extends along the ceiling near the north wall from the service point towards the east portion of the building.

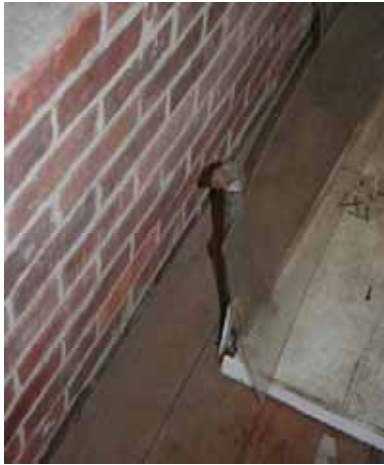
- *Plumbing Systems:* A galvanized pipe near the firebox likely provided water for the wash tubs. It is no longer functional.

*Figure C-39 Galvanized pipe adjacent to wash tubs*

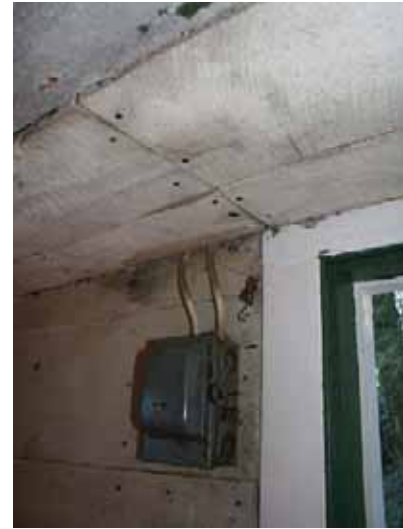
A disconnect box is located on the east wall just north of the door. It is a fuse-type box rated for 125/250 volts and 30 amps, made by General Switch Company. Two modern Romex wires extend up into the ceiling cavity from this box. Records on file indicate that this box was installed in 1976.

**Figure C-48** Disconnect box on east wall of Room 102B, with adjacent replacement ceiling boards

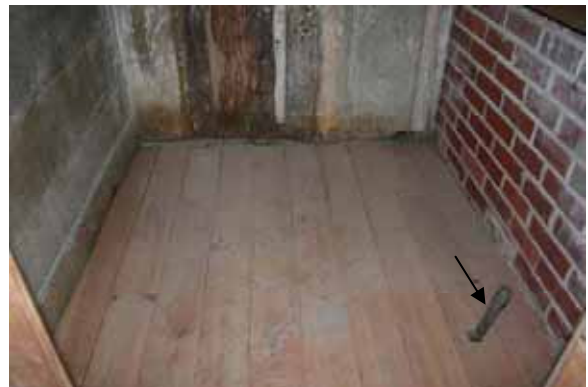
- *Plumbing Systems:* A galvanized pipe near the firebox, now located within the closet, likely provided water for the wash tubs. It is no longer functional.

**Figure C-49** Galvanized pipe and interior of closet

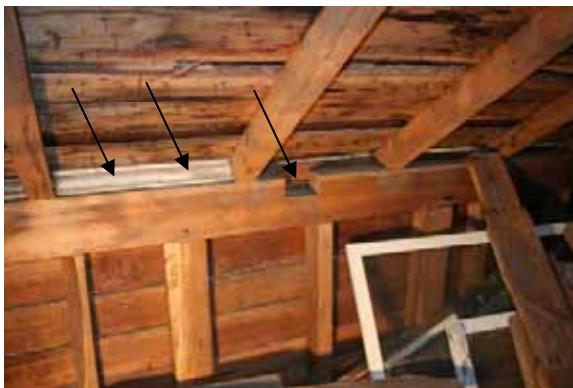
The second floor is a half-story area with exposed wall and roof framing. Wall studs extend up from the floor about 3'-9" to a 4" by 7 5/8" plate supporting the roof rafters. Two large notches in the plates suggest that large tie beams were intended to connect the east and west walls; however, it appears that they were never installed.

**Figure C-54** Notches in top plate suggest collar ties; note painted sections of crown moulding along parts of top plate

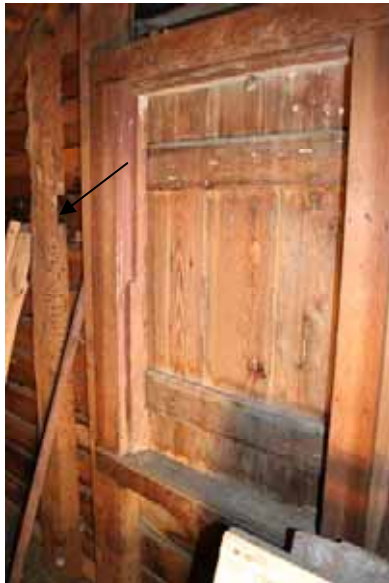
- *Windows:* One window opening is along the south wall. Framed for a double-hung window, this opening is currently protected only by a single board-and-batten shutter. The window's interior casing is a 4" board with an 1/2" applied stop with 3/8" bead. The applied stop is missing along the south jamb and the head.

**Figure C-57** Window opening at south wall of Room 201A, with shutter closed and stud notch indicated

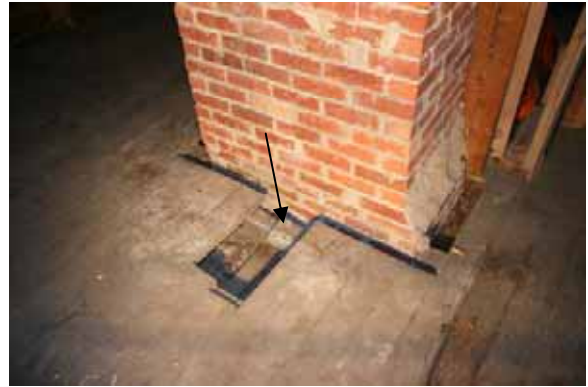
**Figure C-63** Painted sections of baseboard discarded in floor cavity

In a small opening adjacent to the chimney exposing the floor cavity, small sections of painted baseboard seem to have been discarded.

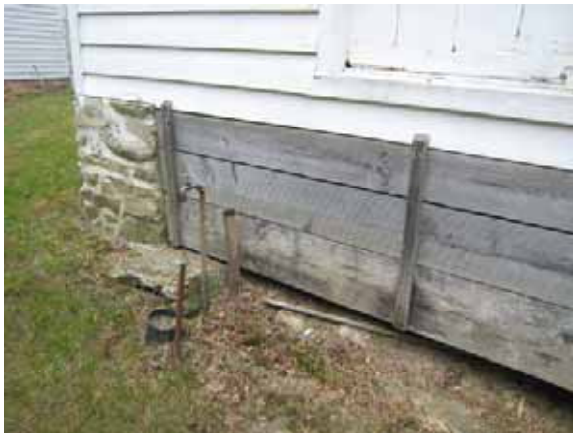
Running water had likely been provided in the Main House in the last quarter of the nineteenth century. Two galvanized pipes adjacent to the wash basins in Rooms 102A and 102B indicate that running water was provided in the Chicken House/Wash House by the Smyths. A hose bibb is located at the exterior near the northwest corner of the building, along the route of the galvanized piping.

**Figure C-65** *Hose bibb at west elevation*
